SECTION **PR**
PROPELLER SHAFT

FRONT PROPELLER SHAFT

REAR PROPELLER SHAFT

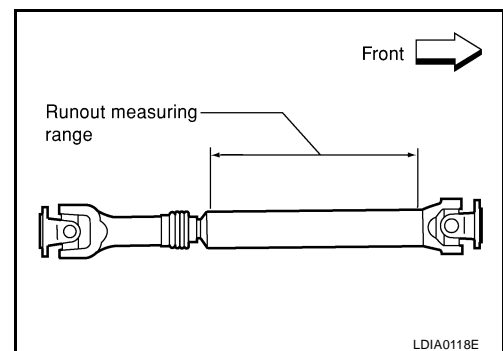
1. Measure the runout of the propeller shaft tube at several points by rotating the final drive companion flange with your hands.

Propeller shaft runout limit : 0.6 mm (0.024 in) or less

2. If the runout exceeds specifications, disconnect the propeller shaft at the final drive companion flange; then rotate the companion flange 90°, 180° and 270° and reconnect the propeller shaft.
3. Check the runout again. If the runout still exceeds specifications, replace the propeller shaft assembly.
4. After installation, check for vibration by driving the vehicle.

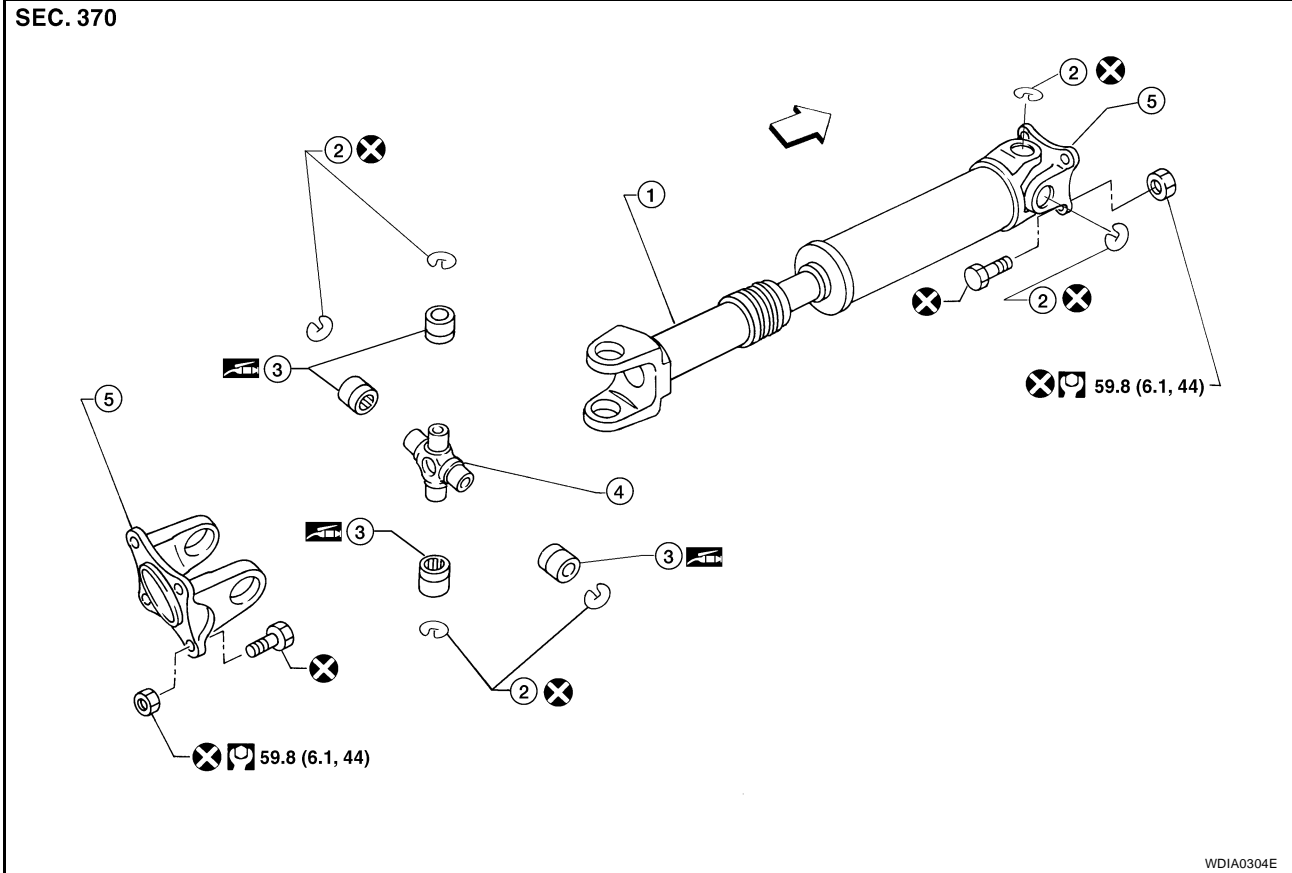
Model 2F1310

| 1. Propeller shaft tube | 2. Snap ring | 3. Journal bearing |
| 4. Journal | 5. Flange yoke | ⇐: Vehicle front |

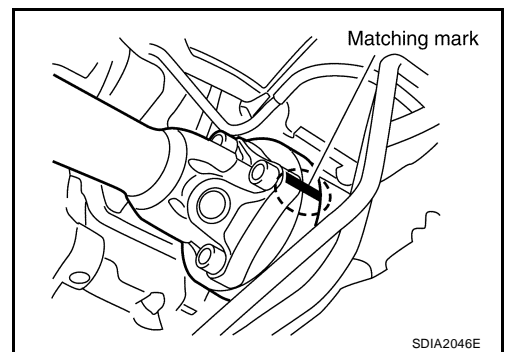
1. Remove the undercover using power tool.
2. Put matching marks on the front propeller shaft flange yoke and the front final drive companion flange as shown.

3. Put matching marks on the front propeller shaft flange yoke and the transfer companion flange.

4. Remove the bolts and then remove the front propeller shaft from the front final drive and transfer.

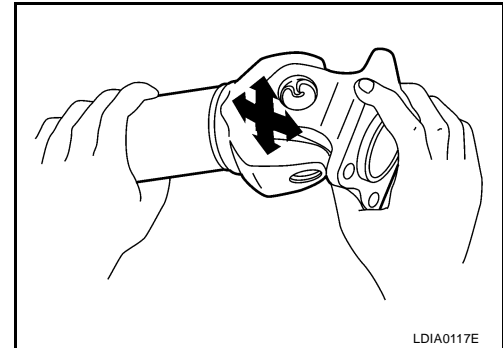
- While holding the flange yoke on one side, check axial play of the joint as shown. If the journal axial play exceeds the specification, repair or replace the journal parts.

Journal axial play : 0.02 mm (0.0008 in) or less

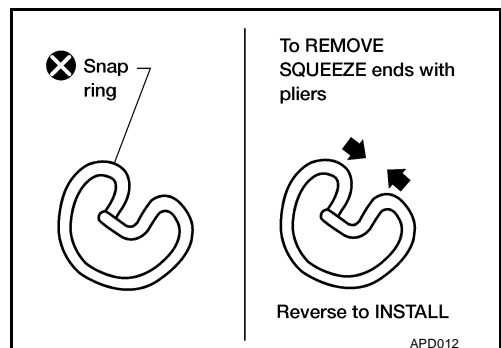
2. Select snap rings that will provide the specified play in an axial direction of the journal, and install them. Refer to [PR-16, "Snap Ring"](#).

Select snap rings with a difference in thickness at both sides within 0.02 mm (0.0008 in).

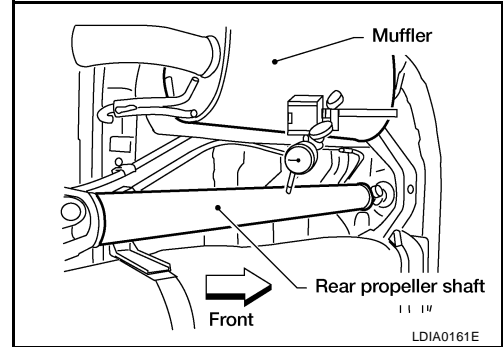
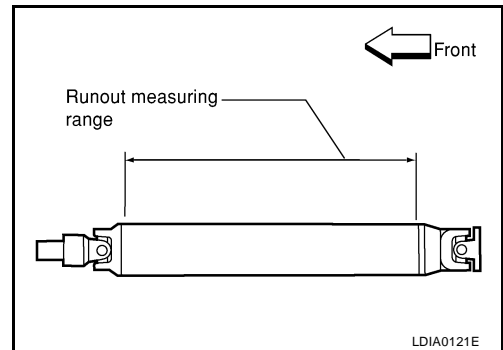
1. Measure the runout of the propeller shaft tube at several points by rotating the final drive companion flange with your hands.

Propeller shaft runout limit

2WD : 1.02 mm (0.040 in) or less

4WD : 0.6 mm (0.024 in) or less

2. If the runout exceeds specifications, disconnect the propeller shaft at the final drive companion flange; then rotate the companion flange 90°, 180° and 270° and reconnect the propeller shaft.
3. Check the runout again. If the runout still exceeds specifications, replace the propeller shaft assembly.
4. After installation, check for vibration by driving vehicle.

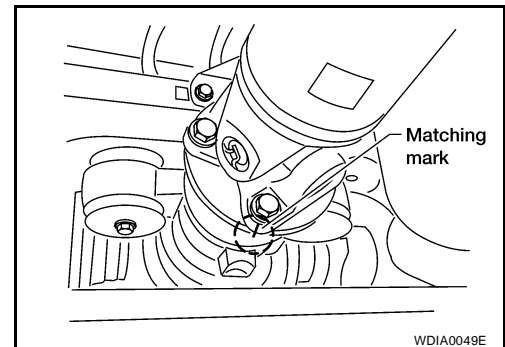
- Put the transmission in neutral and release the parking brake.
- Put matching marks on the rear propeller shaft flange yoke and the rear final drive companion flange as shown.

- Remove the bolts, then remove the propeller shaft from the rear final drive and transmission or transfer.

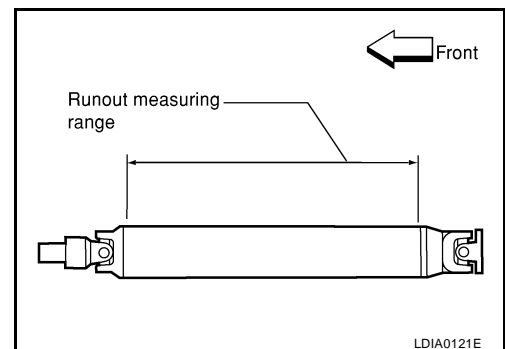
- Inspect the propeller shaft runout. If runout exceeds the limit, replace the propeller shaft assembly.

2WD : 1.02 mm (0.040 in) or less

4WD : 0.6 mm (0.024 in) or less

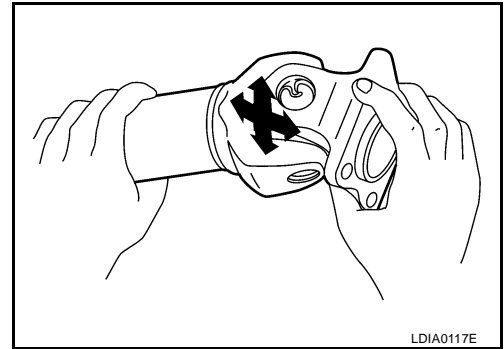
- While holding the flange yoke on one side, check axial play of the joint as shown. If the journal axial play exceeds the specification, repair or replace the journal parts.

Journal axial play : 0.02 mm (0.0008 in) or less

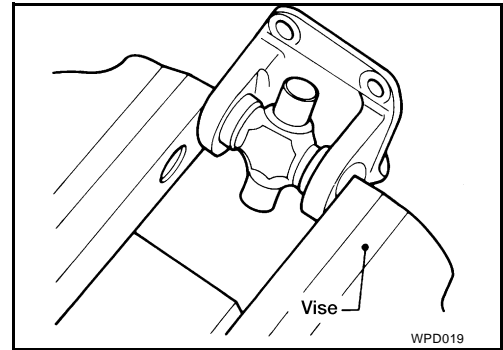
1. Assemble the journal bearings. Apply multipurpose grease on the bearing inner surface.

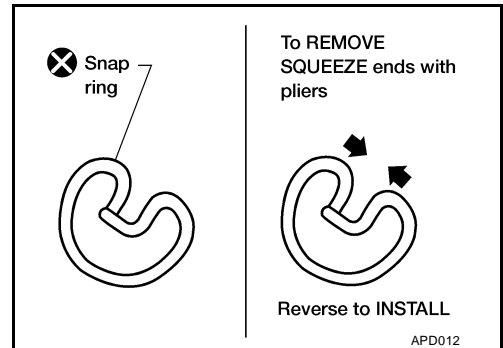
2. Select snap rings that will provide the specified play in an axial direction of the journal, and install them. Refer to [PR-16, "Snap Ring"](#).

Select snap rings with a difference in thickness at both sides within 0.02 mm (0.0008 in).

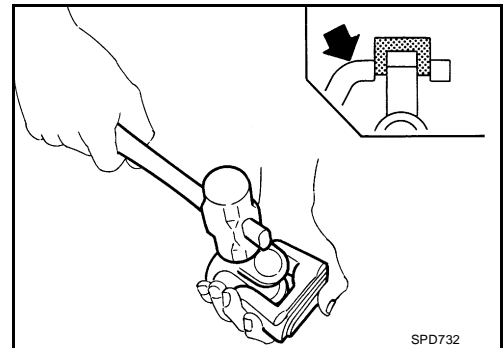
3. Adjust the thrust clearance between the bearing and snap ring to zero by tapping the yoke.

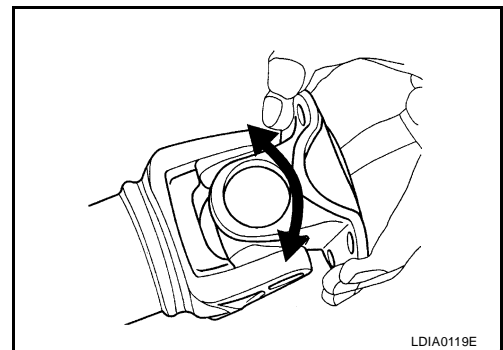
4. Make sure that the journal moves smoothly and is below the joint flex effort specification.

Joint flex effort : 2.26 N-m (0.23 kg-m, 20 in-lb) or less
